NASA Contractor Report 3418

Service Evaluation of Aluminum-Brazed Titanium (ABTi)

S. D. Elrod
Boeing Commercial Airplane Company
Seattle, Washington

Prepared for Langley Research Center under Contract NAS1-13681

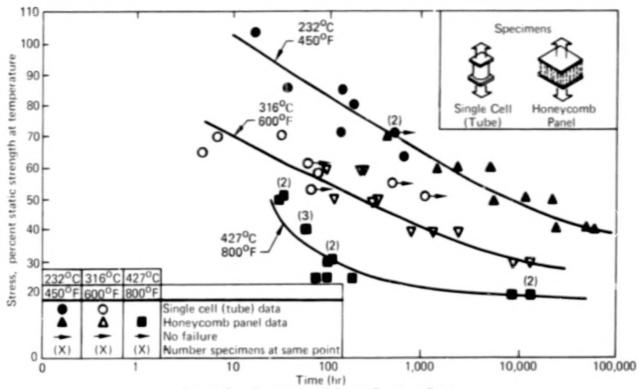
Figure 9.- Summary of Creep-Rupture Data

The results of the honeycomb sandwich stress-rupture tests are shown in figure 9. This figure contains data generated on the SST and DOT follow-on programs as well as the current contract. Failure in all cases occurred in the braze but was attributed to prior creep of the core that relaxed the triaxial stresses at the root of the braze.

The data show—that the flatwise tensile strength of ABTi sandwich is time dependent, with a leveling phenomenon analogous to a fatigue endurance limit. This limit is approximately 40 percent of the static strength sustained load, 4.1 x 10⁶ Pa (600 psi) at 230°C (450°F). At 316° and 425°C (600° and 800°F), the limits are approximately 30 percent and 20 percent sustained load, 2.8 x 10⁶ and 1.4 x 10⁶ Pa (400 and 200 psi), respectively.

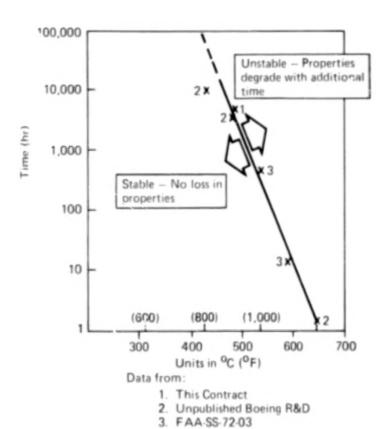
Figure 10. - Metallurgical Stability of ABTi

Specimens from this contract, prior DOT programs (FAA-SS-72-03, ref. 3), and unpublished Boeing R&D programs were sectioned after thermal exposure and the thicknesses of the titanium aluminide (TiAl3) interface layers were measured for growth during the thermal exposure. If no significant growth of the aluminide layer occurred, the braze was considered metallurgically stable at that exposure. Figure 10 is a plot of combined data showing the time/temperature limits. These data reveal that the braze joint has long term metallurgical stability at temperatures up to 425° C (800° F) and is usable at higher temperatures for shorter times.

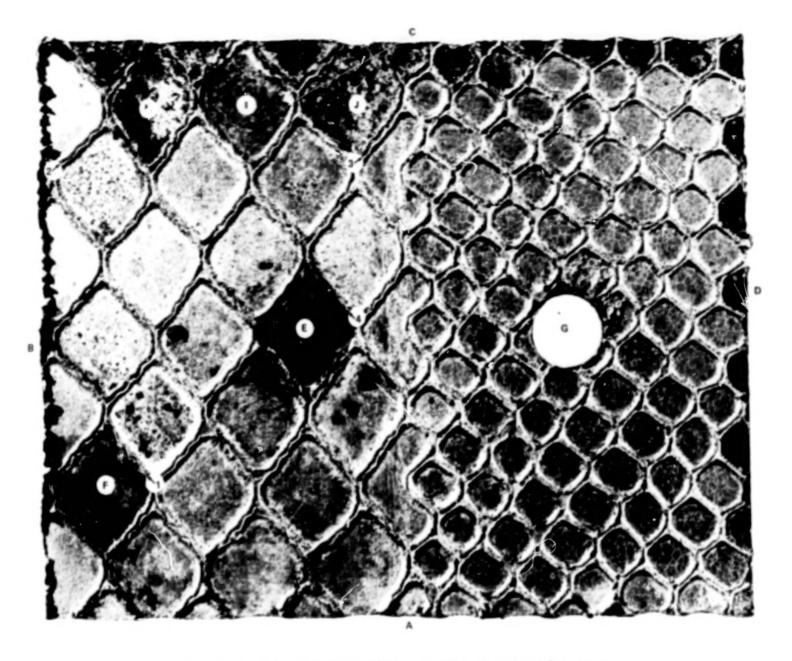
Figure 11.— Face Skin From 727 Landing Gear Structural Specimen

The corrosion morphology on a specimen from the 727 airplane landing gear test is representative, in kind, of all types of specimens and aircraft applications. Figure 11 illustrates salient features. This photo shows the entire 3.8- by 5.1-cm (1.5- by 2.0-in.) face skin removed from a 727 landing gear test specimen. Sides marked A and B were painted with a corrosion protective primer; sides C and D were left bare. G is the attachment hole and E is the cell with a vent hole in one skin. Neither E nor G (on this specimen) received any protective finish (see fig. 1). This particular specimen had been on the airplane for approximately 5 years.

Cells marked H, I, and J had open nodes at the outside edge. Cell F had a small slit at the bottom of a cell wall (see fig. 12). This slit permitted some moisture to enter but also provided a drain such that water could not accumulate. Cell E contained the vent hole in the upper skin that would permit moisture to enter and accumulate without draining. The fastener hole G was not sealed (slip-fit fastener), but was shielded from liquid water by the fastener head. (The deposits around the hole are residual adhesive from bonding loading blocks for the flatwise tensile test.) The fillets marked 1 through 4 are the locations of scanning electron photomicrographs (SEM) discussed later. The various areas illustrate the corrosive behavior of ABTi.

Cell E, with an exposed vent hole, which can accumulate liquid water, represents the worst condition. (Acoustic sandwich that has more and/or larger holes is worse than this specimen because water can enter more readily, but the difference is in amount, not kind.) The entrapped water dries more slowly than an exposed surface, which increases the time the aluminum is wet and, hence, the amount of corrosion. The SEM photograph of fillet 4, figure 16, shows that the exposed side of the fillet is almost completely gone and corrosion has penetrated beyond the cell wall to the inner side of the fillet.

An area such as the fastener hole, G, that is accessible to water vapor but not to liquid water, does not corrode.

The small degradation in the structural specimens revealed by statistical analysis would not occur if (1) all of the edges had been painted and (2) there had been no vent hole. If a crack should develop in service, it would be expected to act similar to the fastener hole (with regard to corrosion), as there would not be sufficient opening to permit ingress of liquid water.

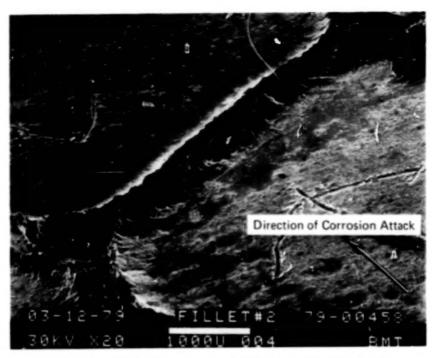
Figure 13.—SEM Photograph of Fillet Number 2 Showing No Evidence of Corrosion Attack

Sides A and B, which were coated with a chromate-inhibited epoxy primer, are representative of any exposed aluminum that has been given an appropriate protective finish. The SUM photograph at cell wall 2, figure 13, shows the surface of the fillet to be smooth with no evidence of corrosive attack. The results confirm prior testing (ref. 1) that an appropriate protective finish prevents corrosion.

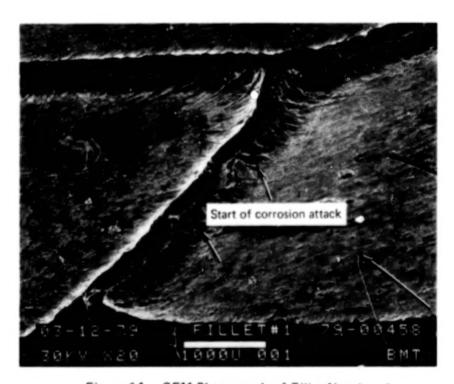
Figure 14.- SEM Photograph of Fillet Number 1

Cell F experienced a minimum exposure to moisture because of the small opening into the cell. The resulting corrosion within the cell was also minimal. The SEM photo of fillet 1, figure 14, shows the initiation of corrosion pits and the start of intergranular attack.

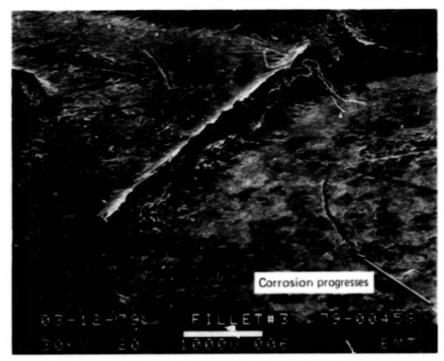
Figure 15. - SEM Photograph of Fillet Number 3

Call J was completely open to moisture. The SEM photo of fillet 3, figure 15, shows that corrosion has progressed along grain boundaries over the entire fillet surface; however, after 5 years, the basic structure of the fillet is still intact and able to sustain load.
